Garden Creek Watershed

Why Are We Here?

- To discuss TMDLs for Garden Creek
 - Total Maximum Daily Load
 - It is how much pollutant can enter the stream and have the stream meet the water quality standards

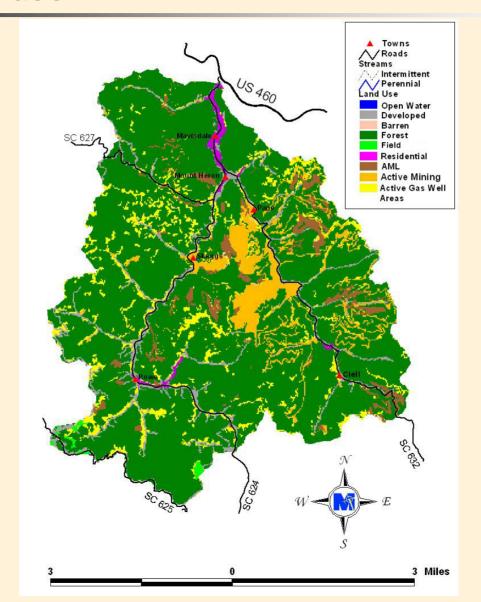
Land use

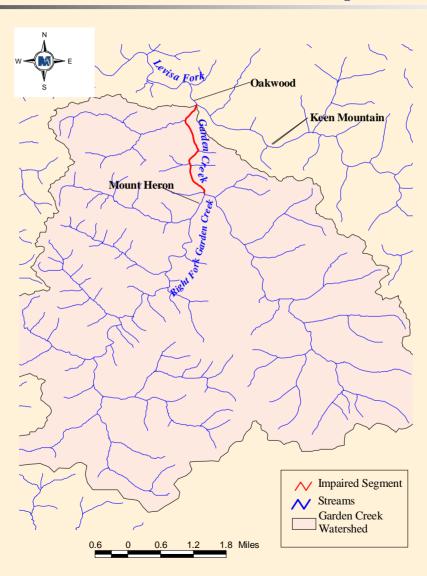
Where is the Impairment?

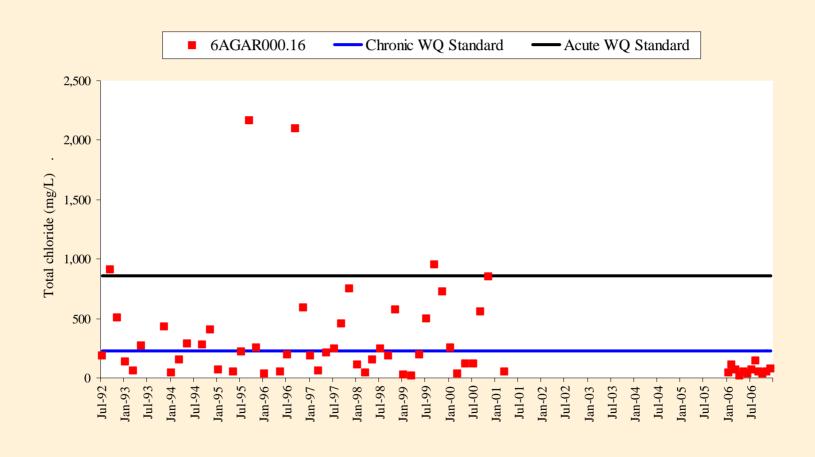
Chloride Concentrations at 6AGAR000.16, July 1992 – December 2006

What Chloride reductions are required?

70 % Reduction

5% Reduction

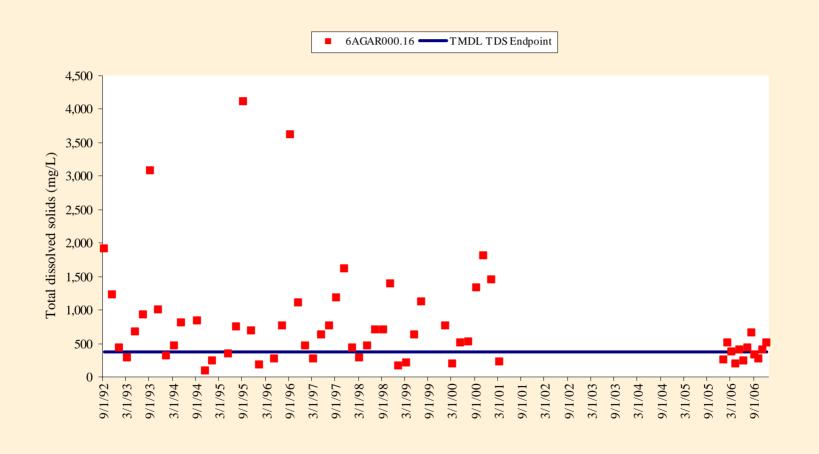
TDS Concentrations at 6AGAR000.16, July 1992 – December 2006

What TDS reductions are required?

77 %
Reduction

45% Reduction

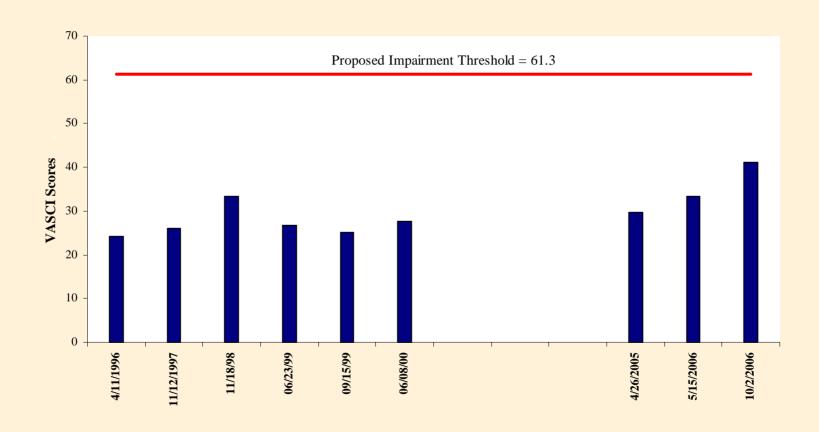
Benthic VACI Scores for 6AGAR000.16, April 11, 1996 – October 2, 2006

The condition of the stream is harmful to aquatic life

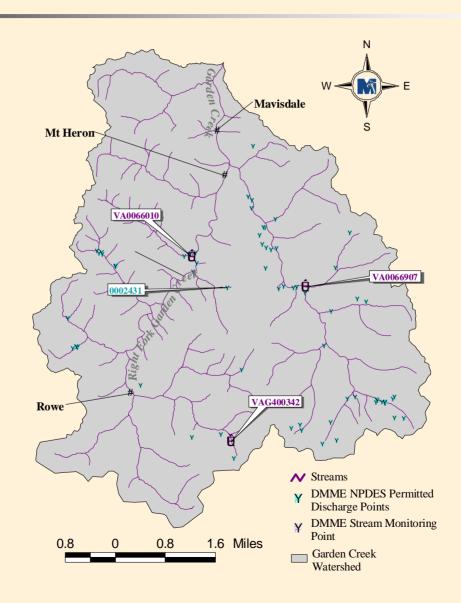
PERMITTED DISCHARGES

Permitted discharges

Wastewater treatment facilities

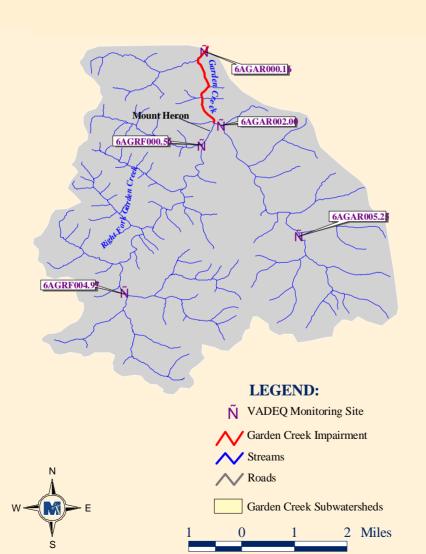
DEQ BENTHIC MONITORING SITES
